ASBESTOS & LEAD PAINT SURVEY

Santa Ana College
Johnson Student Center
1530 W. 17th Street
Santa Ana, California

August 21, 2015
Revised August 30, 2018

TRG Project #8126

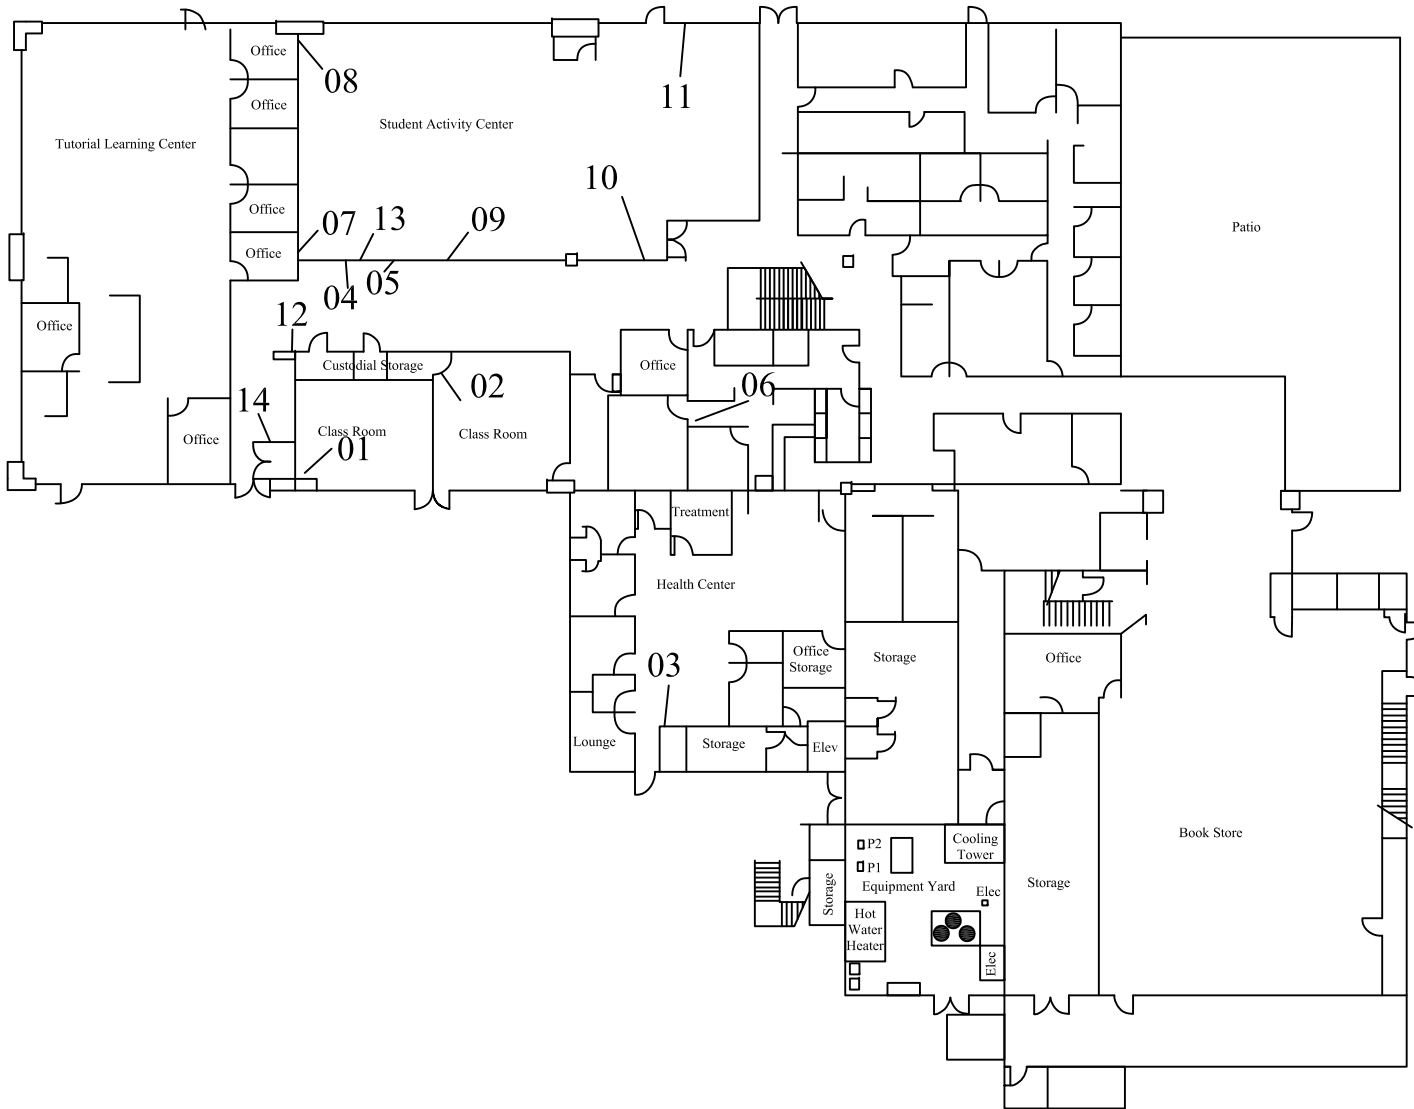
BUILDING U FLOOR PLAN WITH BULK SAMPLE LOCATIONS

- **Concealed Floor Tile/Mastic**-Rooms 104-3, 106, 107 & 107.1 Hallway (Floor 1)
- **Mastic Below 12 inch “Rose” Floor Tile**-Floor 1 Hallway-west end
- **Mastic Below 12 inch “White” Floor Tile**-Floor 2 Food Services, Dining Area and Hallway

To comply with South Coast Air Quality Management District's Rule 1403, the identified asbestos-containing materials must be properly removed prior to starting demolition work on the buildings. Properly licensed professionals should be used to perform abatement work and appropriate air sampling should be conducted during the abatement activities.
