## **ASBESTOS OPERATIONS AND MAINTENANCE PLAN**

1530 West 17<sup>th</sup> Street  
Santa Ana, California 92706

Rancho Santiago Community College District  
2323 North Broadway  
Santa Ana, California 92706

Project No.: RSCC-17-6814

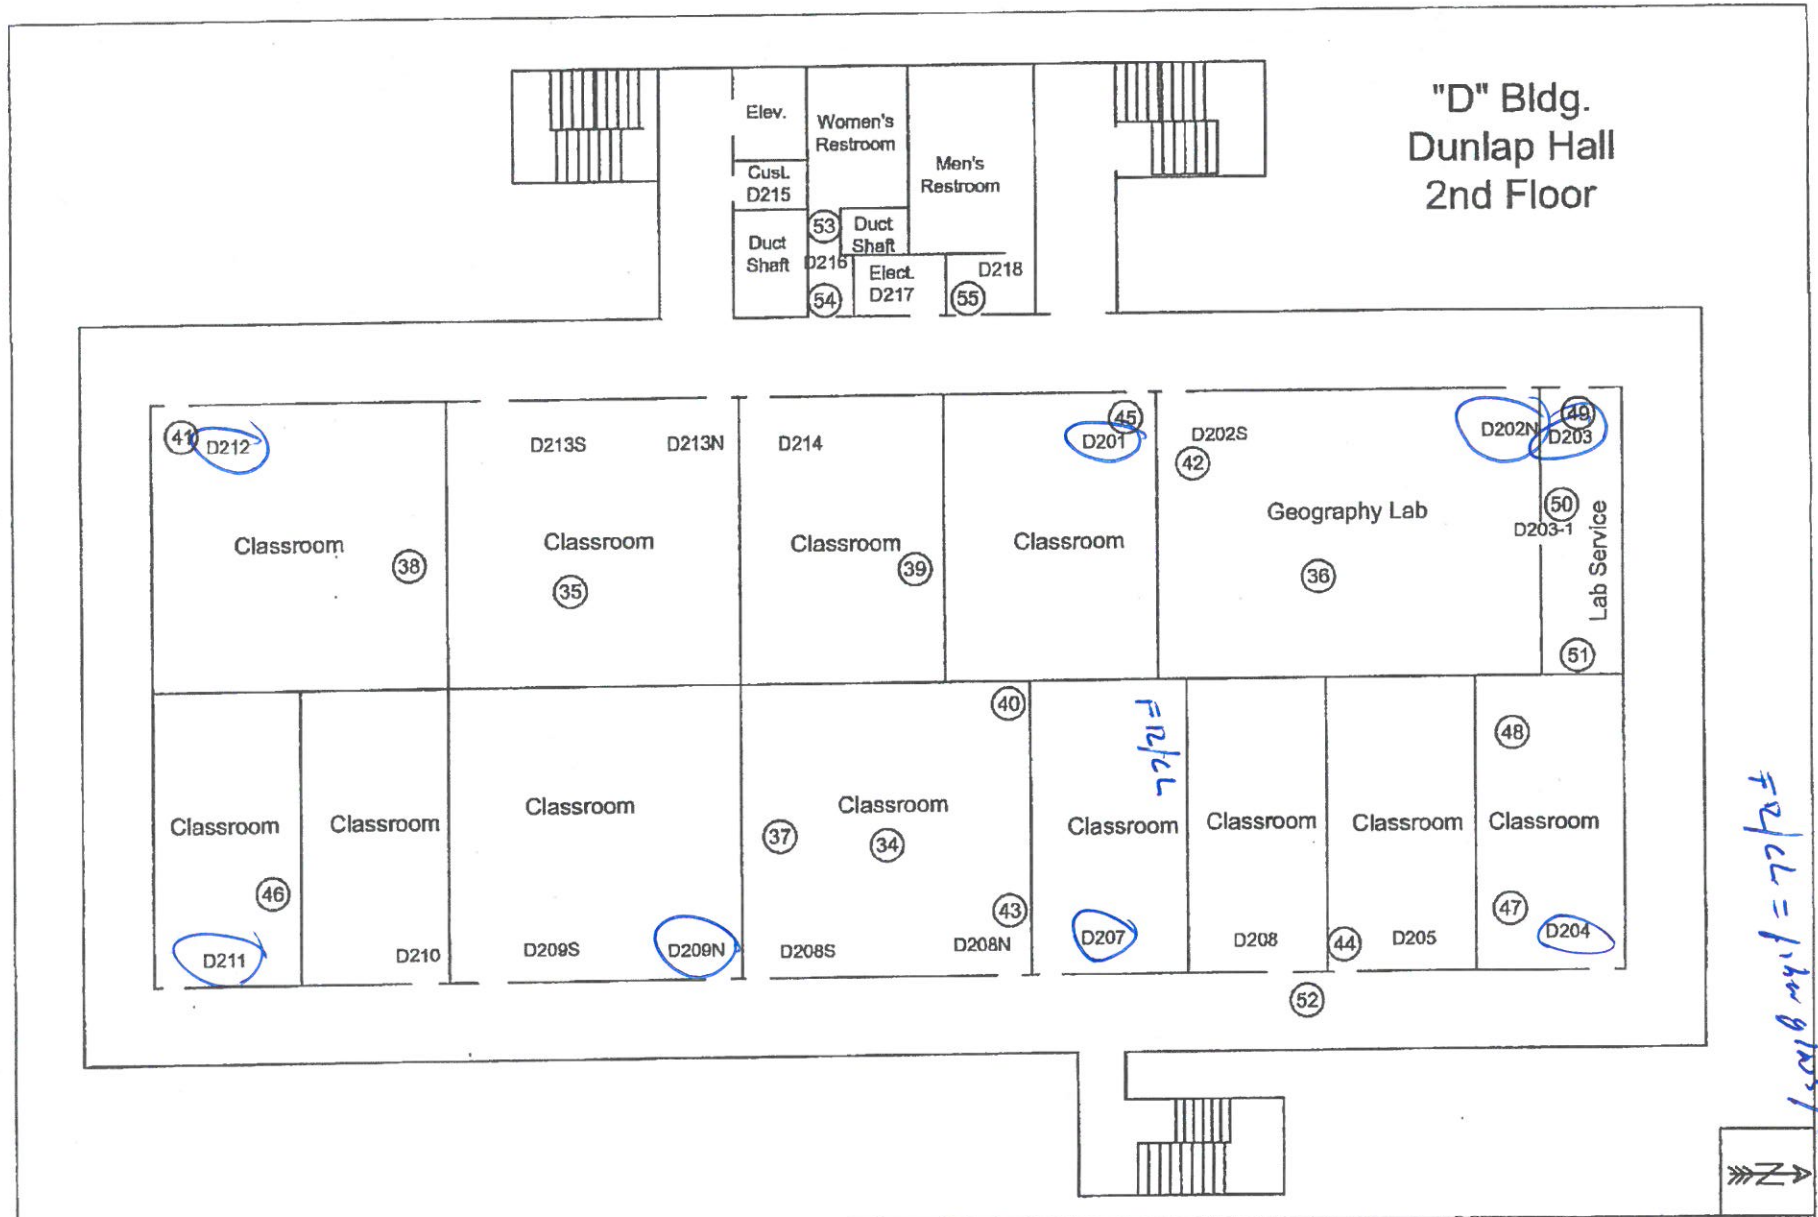
"D" Bldg.  
Dunlap Hall  
2nd Floor

Fiber glass / cloth in wall
